## Summary report Ageing Management Review

Under the contract of N.V. EPZ

Author(s):	[Redacted]	reviewed:	[Redacted]
name:	Summary report vC final.docx	approved:	[Redacted]
Reference:	NRG-22503/11.109273		
126 pages	June 2012

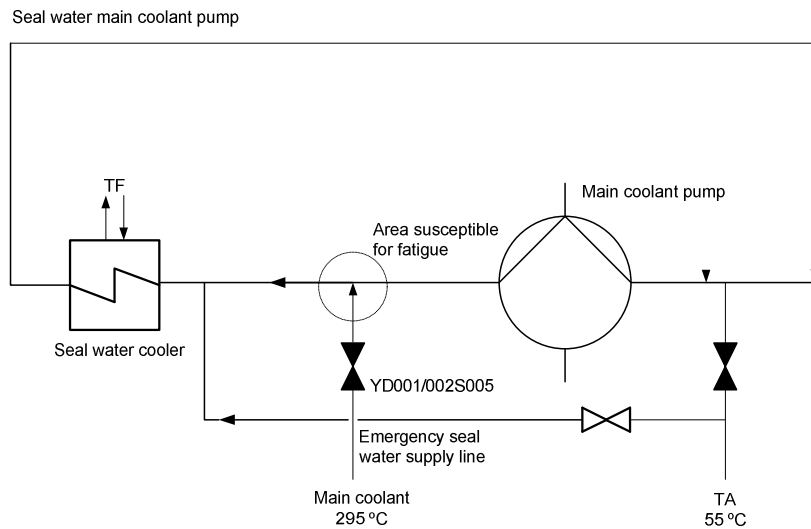
Figure 3-1 Schematic overview of seal water cycle of the main coolant pump

As the emergency seal water supply lines (YD001/002 Z003, Z005, S005) may be subjected to thermal transient conditions and no fatigue calculations were performed for the mechanical joints or the relevant auxiliary lines, an evaluation of these transients should be performed [15].

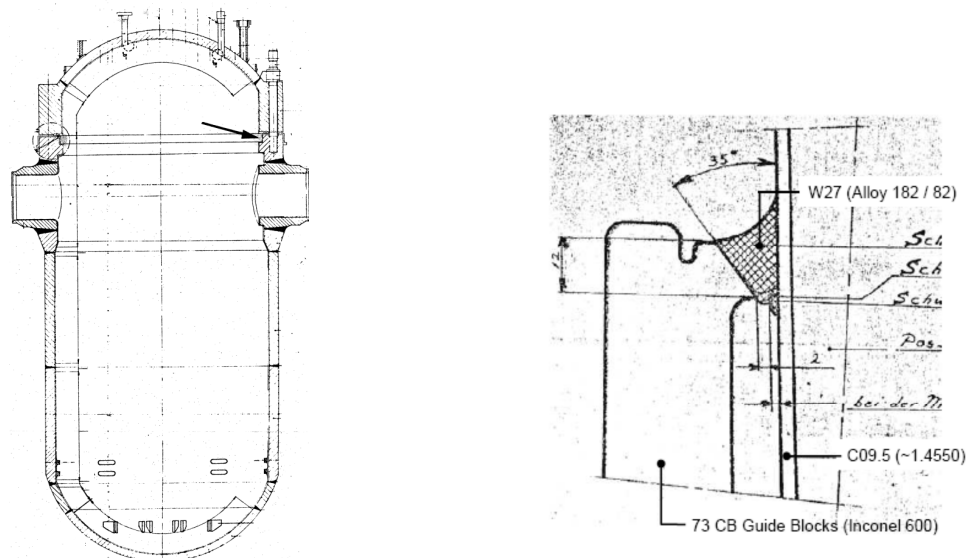
Figure 3-2 Left sketch RPV (arrow indicates core barrel guide blocks) and right sketch of core barrel guide block weld

PWSCC is a relevant ageing mechanism for the core barrel guide blocks and associated welded joints between the internal cladding of the vessel flange on the upper cylindrical shell and the core barrel guide blocks (Figure 3-2). If any crack initiates in the core barrel guide blocks welds, it may affect the integrity of the internal cladding of the RPV. Therefore, it is necessary that the associated welds of the core barrel guide blocks are periodically inspected. KCB performed the last visual inspection (VT-3) in 2004. However, VT-3 only determines the overall mechanical and structural condition of the core barrel guide blocks and its supports and is therefore not considered adequate to detect defects in the inspected area.

In the AMR of the RPV it is recommended that KCB performs a VT-1 inspection of this location (in particular the weld joints) to determine the surface condition and to identify any defects or degradation effects, such as cracking, erosion, abrasion, corrosion or wear. Furthermore, if cracks are detected during ISI activities and found to be beyond acceptance criteria, the core barrel guide blocks and associated weld joints should undergo further investigation, to determine if replacement with more PWSCC resistant components or weld joints is required. With this additional activity PWSCC of the RPV is adequately managed [11].
